FLOATING AIR BASES AND FLYING BOATS: AN HISTORICAL AND
ARCHAEOLOGICAL STUDY OF THE TWO SEADROMES ESTABLISHED AT SAIPAN

May 2020

A Thesis

East Carolina University

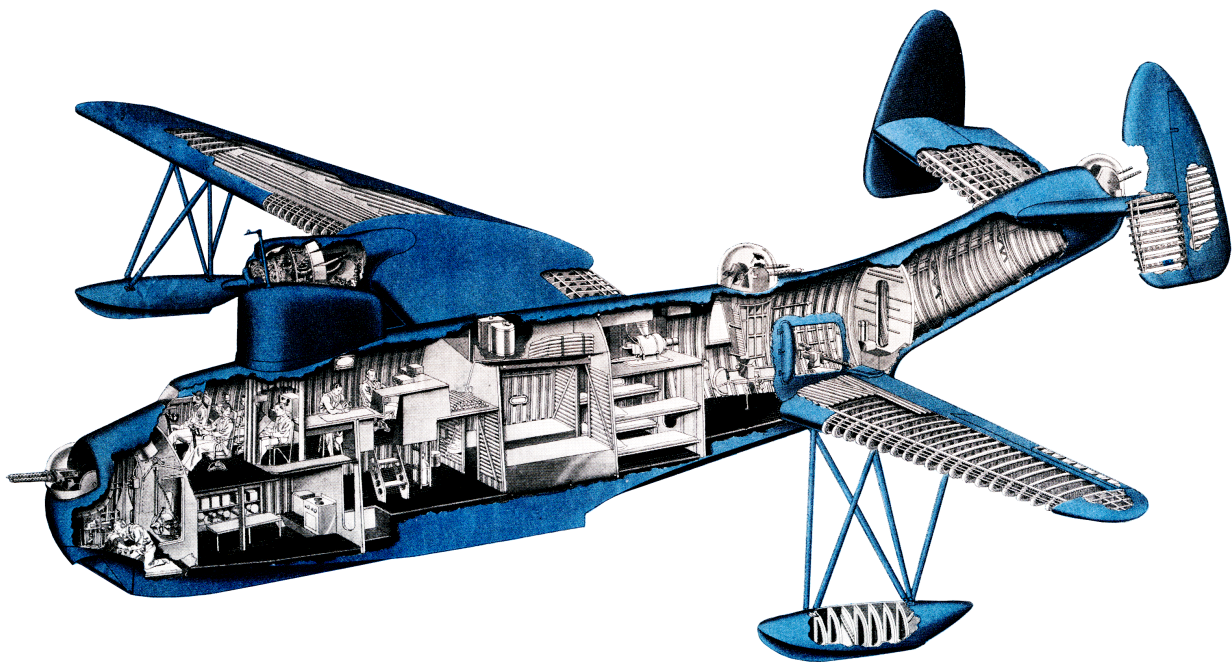
FIGURE 2.1. Interior layout of PBM-5, very similar to PBM-3D (Image courtesy of weaponsandwarfare.com/2019/01/16/martin-pbm-mariner/).

The PBM-3D had numerous improvements over previous variants. Stronger, fixed, strut-mounted wing floats replaced weaker retractable ones and bomb capacity was increased by enlarging the nacelles. Powered turrets were located in the nose, top deck, and tail, all with dual .50 caliber machine guns in powered turrets. Single gun mounts of the same caliber were also on both sides of the waist. Armor was added for better crew protection and 1,600 hp Wright R-2600-6 engines were replaced with the larger Wright R-2600-22 engines producing 1,900hp sporting four-bladed propellers. A powerful AN/APS-15 airborne radar system was aboard with its antenna mounted in a large elongated dome mounted immediately atop and aft of the cockpit. The aircraft was separated into two levels and five water-tight compartments. “Maximum speed

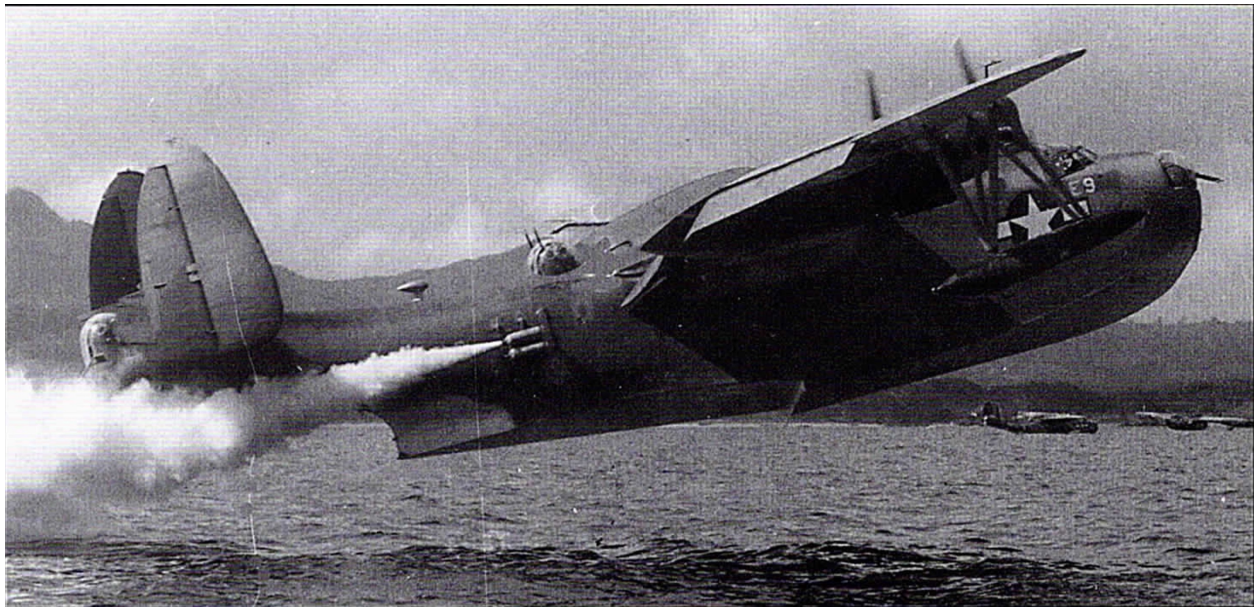
FIGURE 2.2. Original caption: "VBP-27 PBM-5 E9 also at Kerama Retto making a JATO take-off on 8 August 1945 (Image courtesy of Ginter, Steve. "Naval Fighters Number Ninety-Seven: Martin PBM Mariner" Page 173).

Empty JATO cylinders were jettisoned soon after the aircraft was airborne and could be replaced simply by opening the hatch and mounting fresh units (FIGURE 2.2).

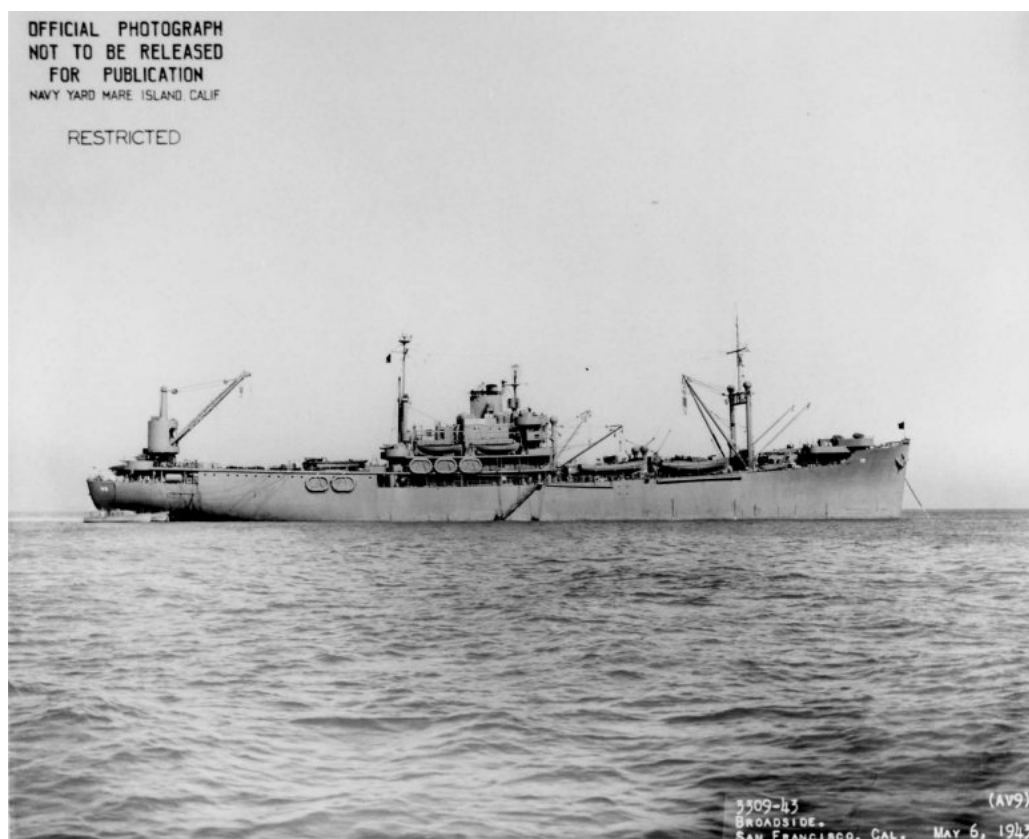
FIGURE 2.4. USS *Pocomoke* (AV-9), a C-3 Merchant Conversion class tender (Image courtesy of Navsource.org/archives/09/41/4109.htm).

print shop, “ready rooms” where pilots would receive their pre and post-flight briefings, as well as quarters for the ship’s crew, maintenance crews (called “patrol service units” [PATsUs]), and aircrew (Owen 1994). In order to save space, aircraft engines and armament were brought aboard in pieces and assembled on site. Torpedoes were especially detested by the assembly teams as it was claimed that they had “5,555 parts” (Owen 1994:17). As they were ideal transport and assembly platforms, many of the seaplane tenders would be relegated to being cargo transports in the early years of the war when merchant ships were few in numbers (FIGURE 2.4).

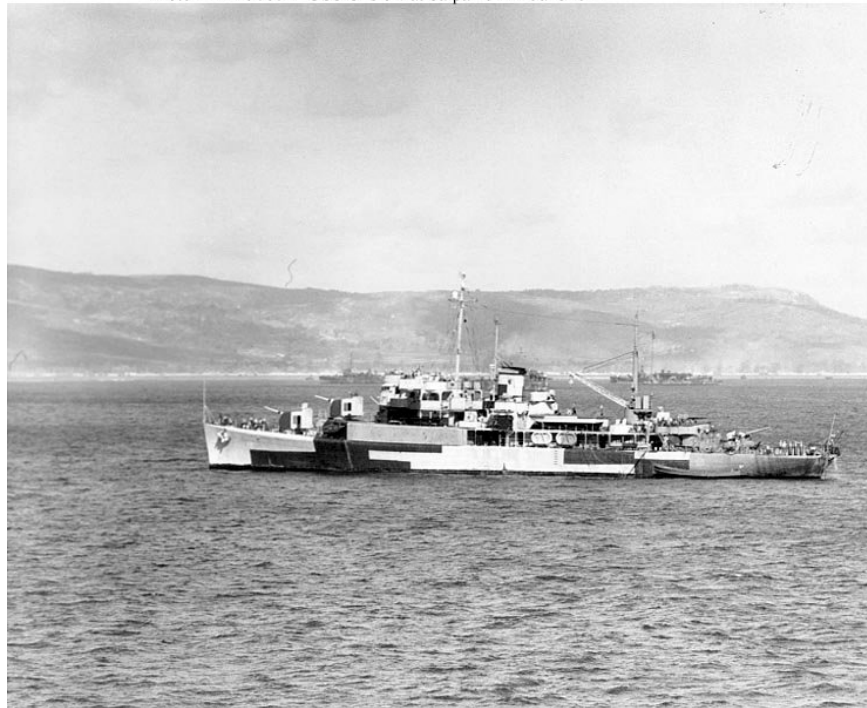
FIGURE 2.5. USS *Onslow* (AVP-48), A *Barnegat* class seaplane tender at Saipan (Image Courtesy of NavSource.org./archives/09/43/4348.htm).

Beginning in 1938, the purpose-built *Barnegat* class AVPs began to roll out of shipyards. These were 311 ft long, with a 41 ft beam, capable of eighteen knots and had a displacement of 2,800 tons and an 85,000-gallon aviation fuel capacity. Like the larger AVs, the *Barnegat* class had extensive repair and supply facilities and were designed to support up to a full squadron.

They did not have a crane capable of hoisting a flying boat out of the water and on deck, but were equipped with several refueling, rearming, and personnel boats that could handle basic servicing of aircraft in good weather conditions (Hoffman 2004). Each *Barneget* class tender could berth six PBM flight crews (FIGURE 2.5) (Guttman 2004).

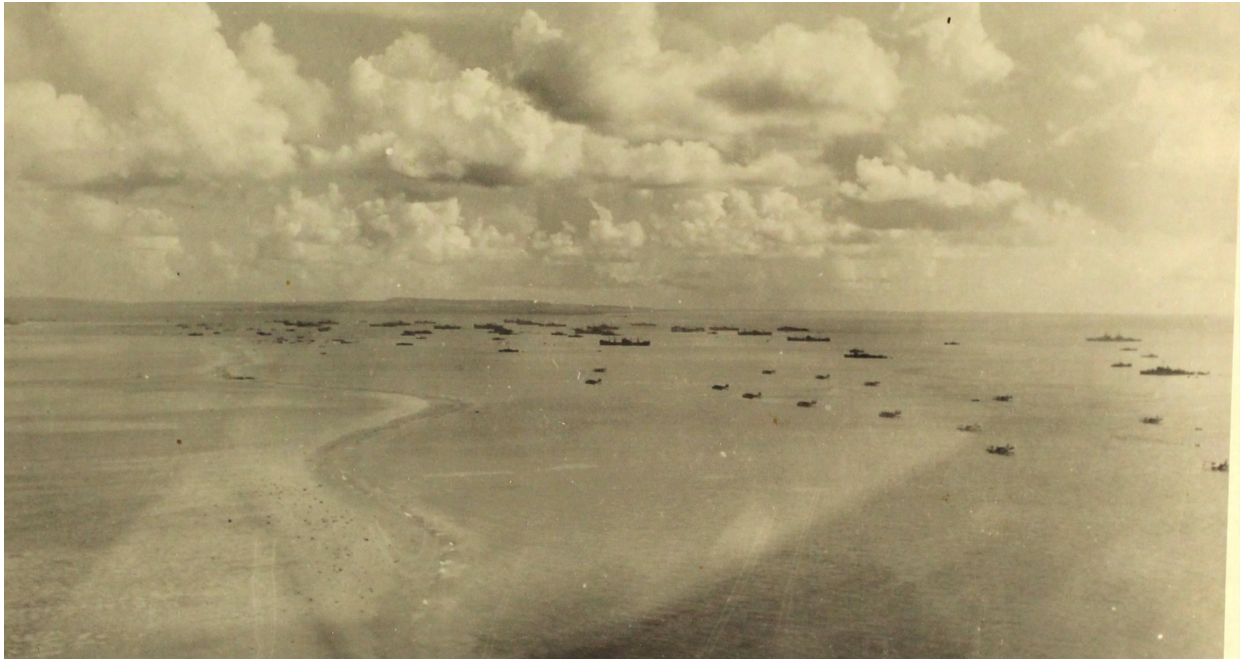
FIGURE 3.2. Garapan Roads anchorage off of Saipan. Note the moored PBMs. Photo likely taken of the final location of Garapan Roads (Image courtesy of U.S. Army Signal Corps and Fold3).

Although the threat from the First Mobile Fleet had passed, U.S. forces at Saipan were still a prime Japanese target. Protecting the avenues of approach and withdrawal to the island was necessary for the duration of the battle and far beyond. "The closest American-held support base, Eniwetok, was 1,000 miles away. The Marshalls lay 1,500 miles to the east. Such a 'giant step' made the use of the flying boat requisite in handling the vital protective searches. Until airfields on Saipan were secure, no land planes were adequate in range to patrol the approaches to the Marianas" (Kammen 1959: 5-6). Hence, as the fighting raged ashore for the rest of June and into July, flight and tending operations continued at Garapan Roads. VP-16 was joined by VH-1, VP-216, VP-72, and VP-202 on 20 June, 23 June, 26 June, and 17 July, respectively. Between 17 June and 10 August 1944 alone, PBM-Mariners flew a total of 592 missions out of the open-roadstead and hundreds more thereafter (Kammen 1959: 78) (FIGURE 3.2).

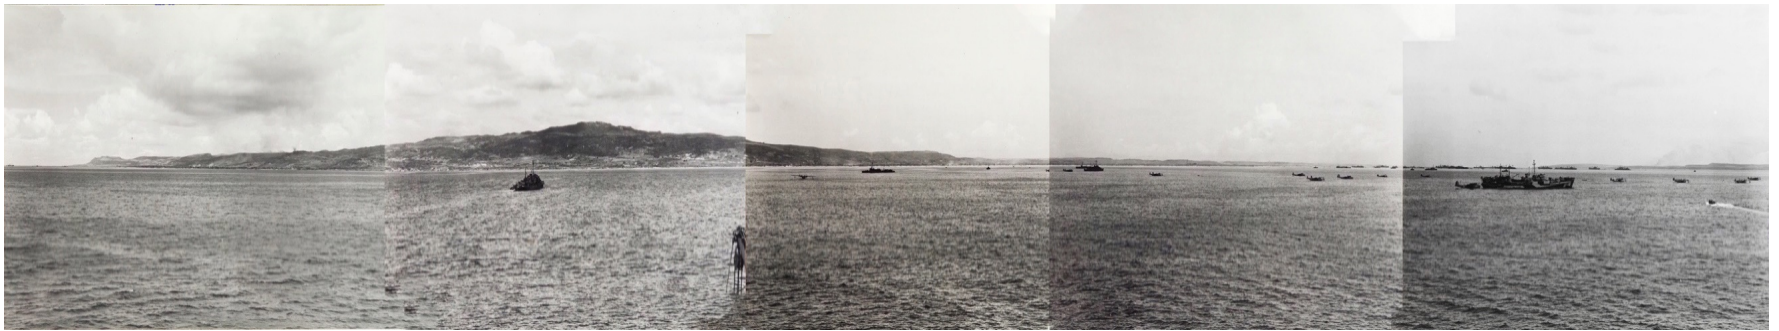
FIGURE 3.3. Panoramic view of the Garapan Roads Seadrome as seen from the deck of the USS *Chandeleur* compiled from photographs taken on 27 and 29 June 1944. Note the PBM Mariners. Vessels present in the photograph from left to right: *Mackinac* (AVP-13), *Ballard* (AVD-10), an unidentified vessel, *Mackinac* (AVP-13) again, and *Onslow* (AVP-48) (Photographs combined by author. Original images courtesy of the NARA RG 38).

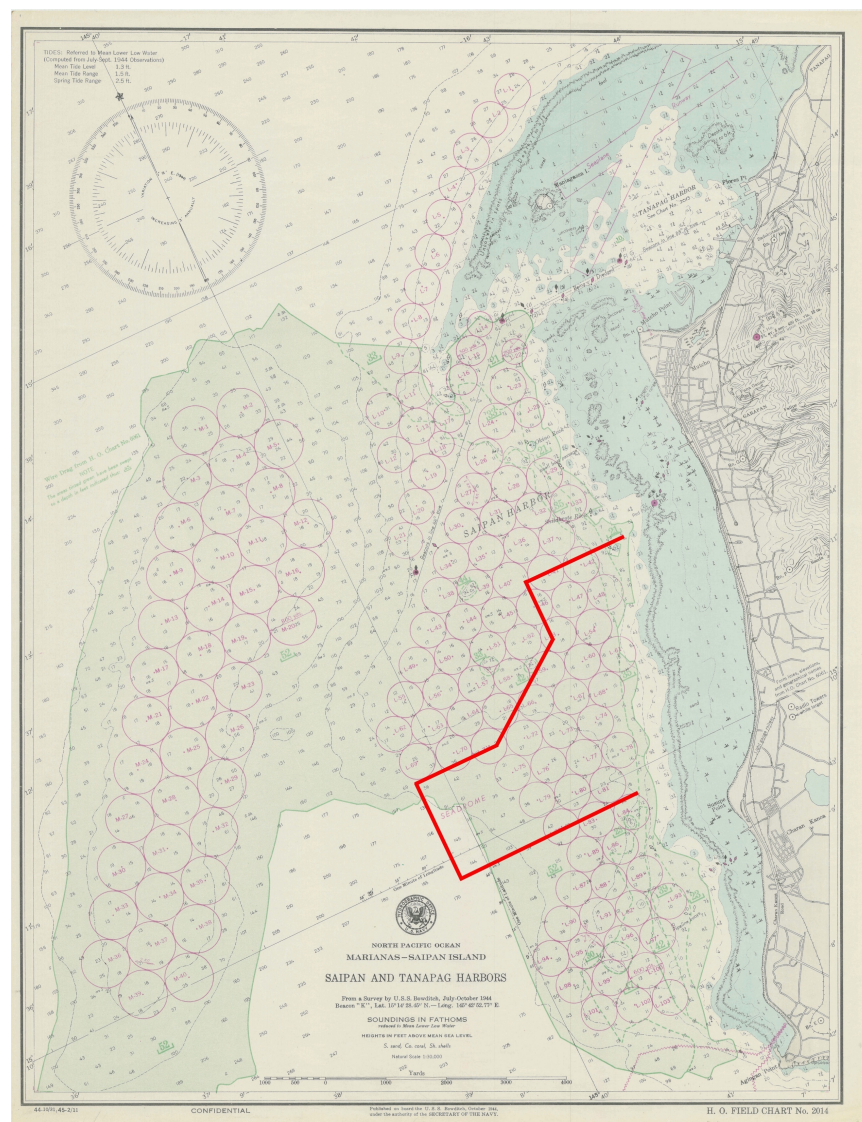
FIGURE 3.4. Mobile Hydrographic Office Chart 2014: Saipan and Tanapag Harbors. Note Tanapag Lagoon to the North East. Lines denoting seadrome area on the chart have been enhanced by author (Image courtesy of the NARA, Record Group 37).

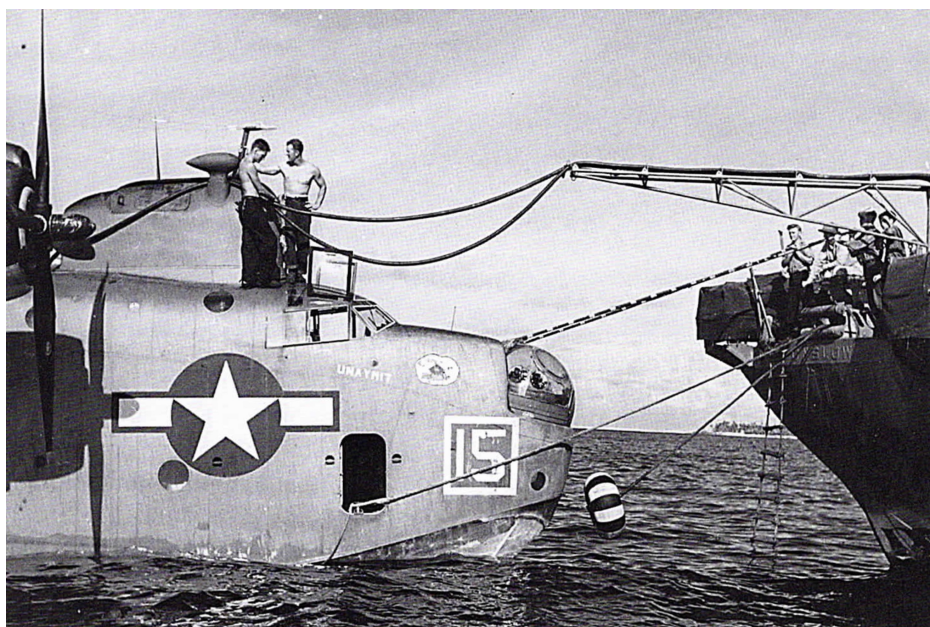
FIGURE 3.5. Original caption: "VPB-17 PBM-3D 'Unaymit' being refueled by the USS *Onslow* in December 1944." Note the fuel boom on the stern being used (Image courtesy of Ginter, Steve. "Naval Fighters Number Ninety-Seven: Martin PBM Mariner" page 149).

The better option was to refuel from the stern of an AVP or AVD tender via gas hoses, but this, too, was intended for calm waters as the aircraft were fairly close to the ship in order for crews to handle the heavy hoses. In rough water there was a high risk of the aircraft colliding with ship's stern and a distance of 50 to 60 ft had to be maintained to avoid this. Passing the heavy hoses over that distance was difficult and hazardous and so crew of *Onslow* were forced to improvise. A portable boom that cradled two gasoline hoses and an oil hose was engineered and mounted on the stern. The boom greatly diminished the dangers to crew and aircraft and

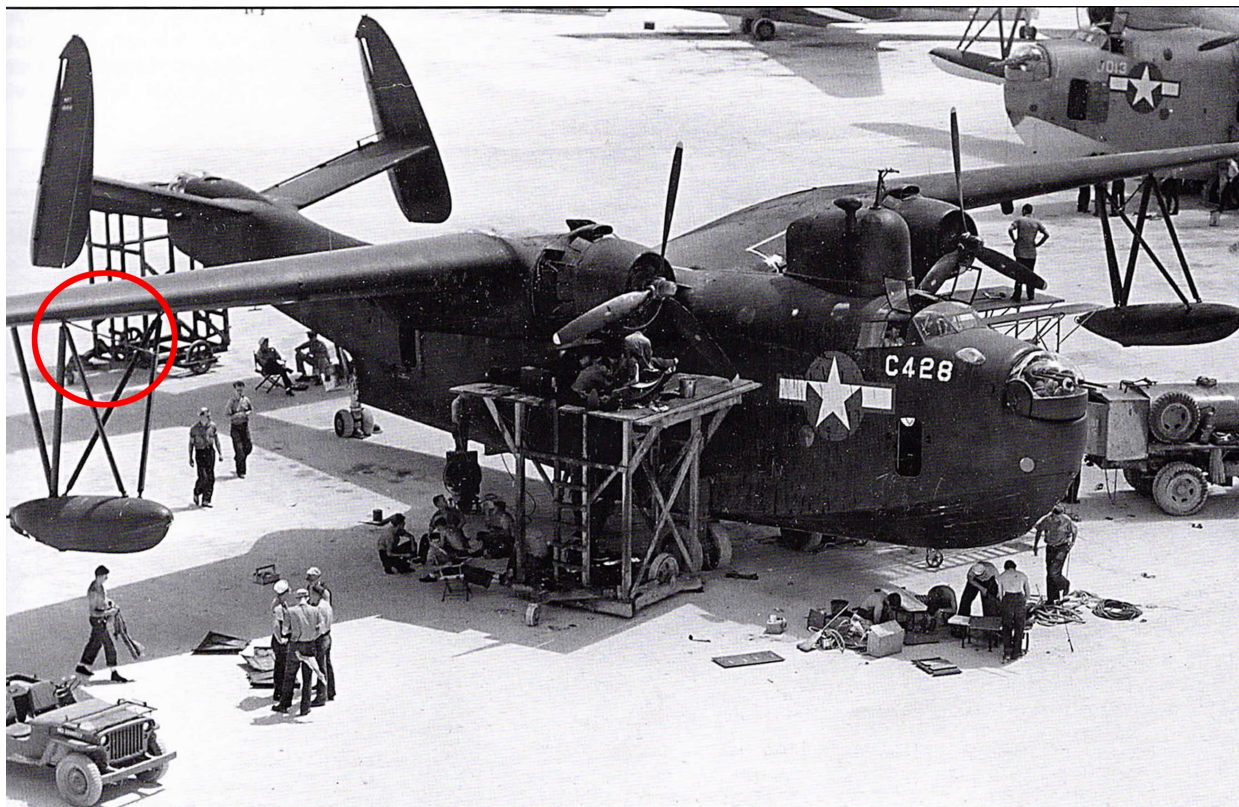
FIGURE 3.6. A PBM-5 of VPB-26 at Tanapag, Saipan, in 1945. Note what is believed to be the jury-strut. Visual emphasis added by author (Image courtesy of Ginter, Steve. "Naval Fighters Number Ninety-Seven: Martin PBM Mariner" Page 169).

The PBM's wing-floats had difficulty standing up to the severe shocks on take-offs and landings caused by the high swells. Two PBMs lost their floats and struts during the Saipan operation and nearly sank before they could be lifted from the water. "This led to a suggestion by Captains Weimer and Taff whereby a jury strut was incorporated on the wing-float assembly to strengthen them for a fore and after shock...[Following] this essential change, very few failures occurred" (Patrol Squadron Two Hundred Sixteen War History 1945: 41). It is believed that this was later incorporated into PBM production as jury struts are visible on many later Mariners (FIGURE 3.6).

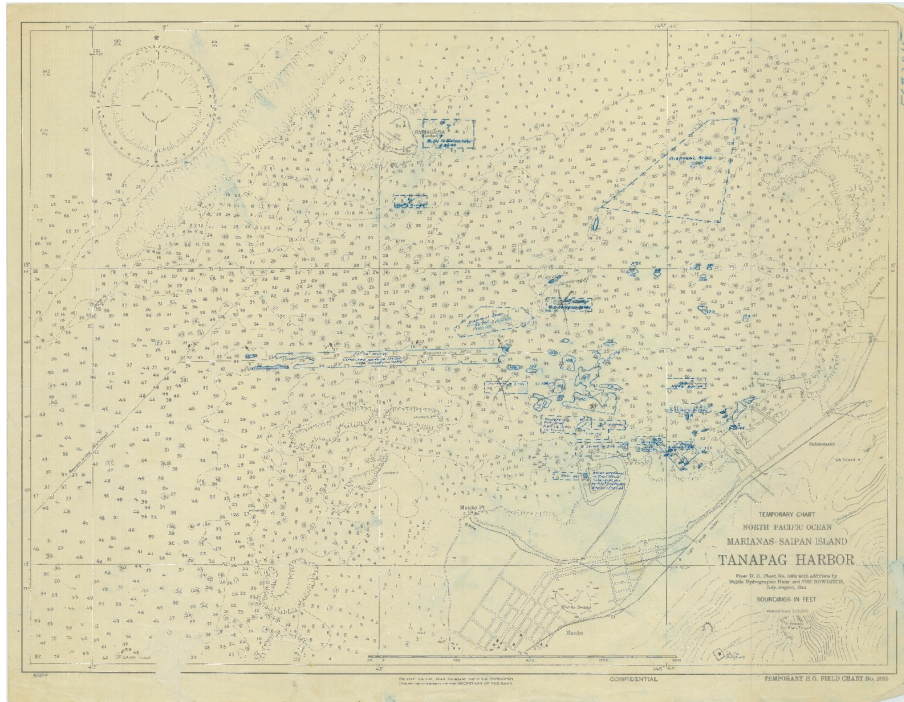
FIGURE 3.8. Hydrographic Office Field Chart 2015-A published aboard USS Bowditch. Note the hand-drawn locations of wrecks and disposal areas (Chart courtesy of the NARA, Record Group 37).

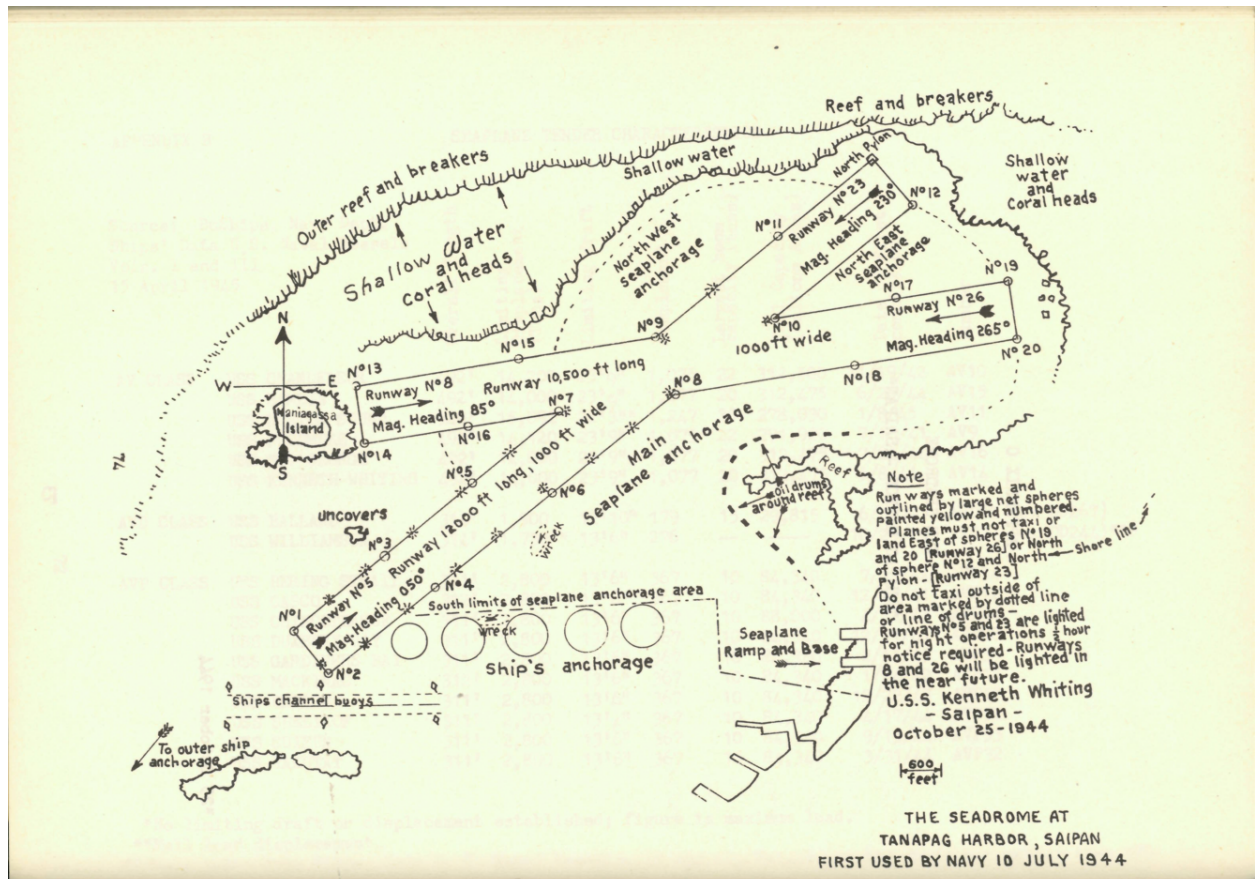
FIGURE 3.9. Patrol Squadron 216 map of Saipan Seadrome and facilities. Note the tender ship moorings just outside of the southern portion of the anchorage (Image courtesy of Kammen, Michael G., “Operational History of the Flying Boat: Open-Sea and Seadrome Aspects, Selected Campaigns-World War II.” Page 74).

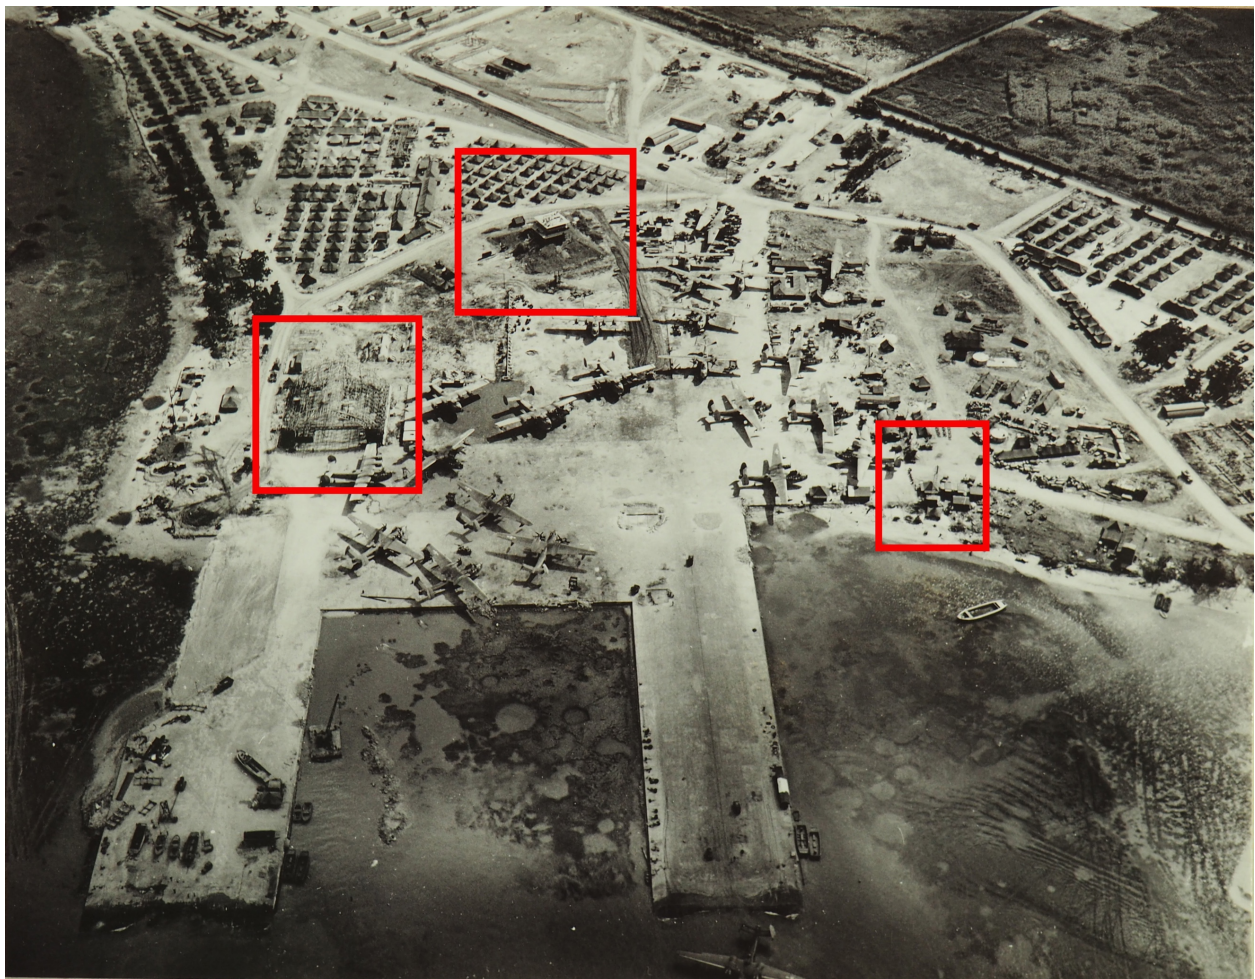
FIGURE 3.10. Aerial view of the terrestrial facilities at NAB Saipan in November 1944. Note the remains of Japanese hangar (left), the control tower (center) and the front range tower (right) (Image courtesy of CNMI HPO. Edited by author for emphasis).

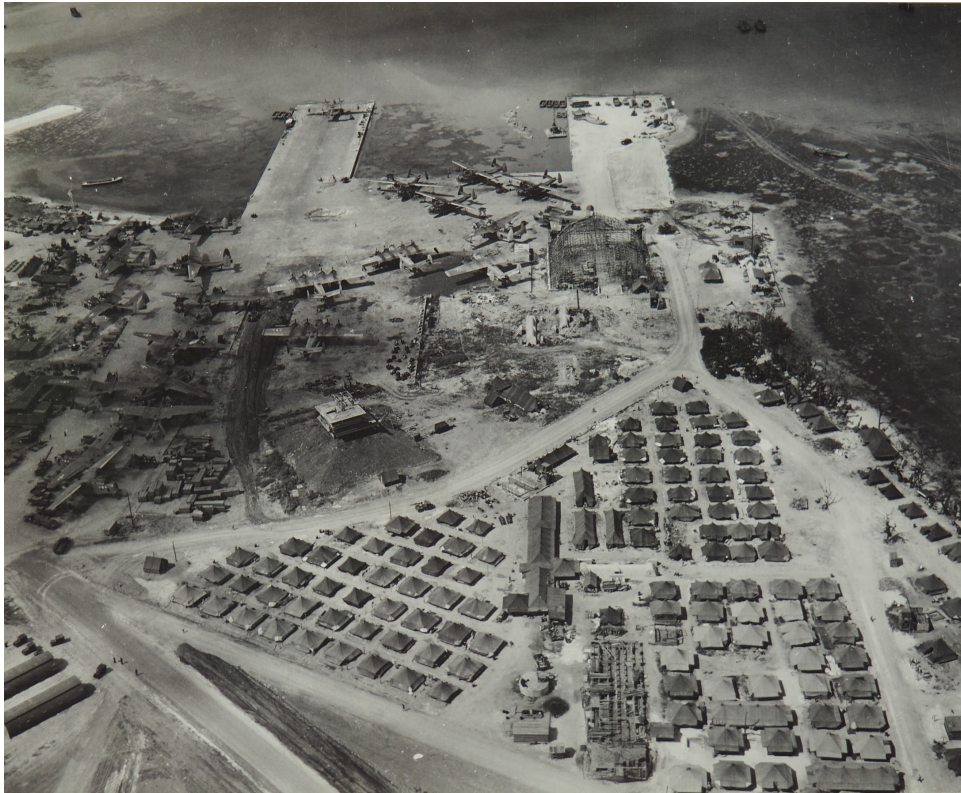
FIGURE 4.1. Aerial photograph taken 10 November 1944 of Flores Point Seaplane Base. Notice the tents, Quonset huts, control tower, hangar, and the numerous PBMs and PB2Ys undergoing maintenance (Photograph courtesy of CNMI HPO).

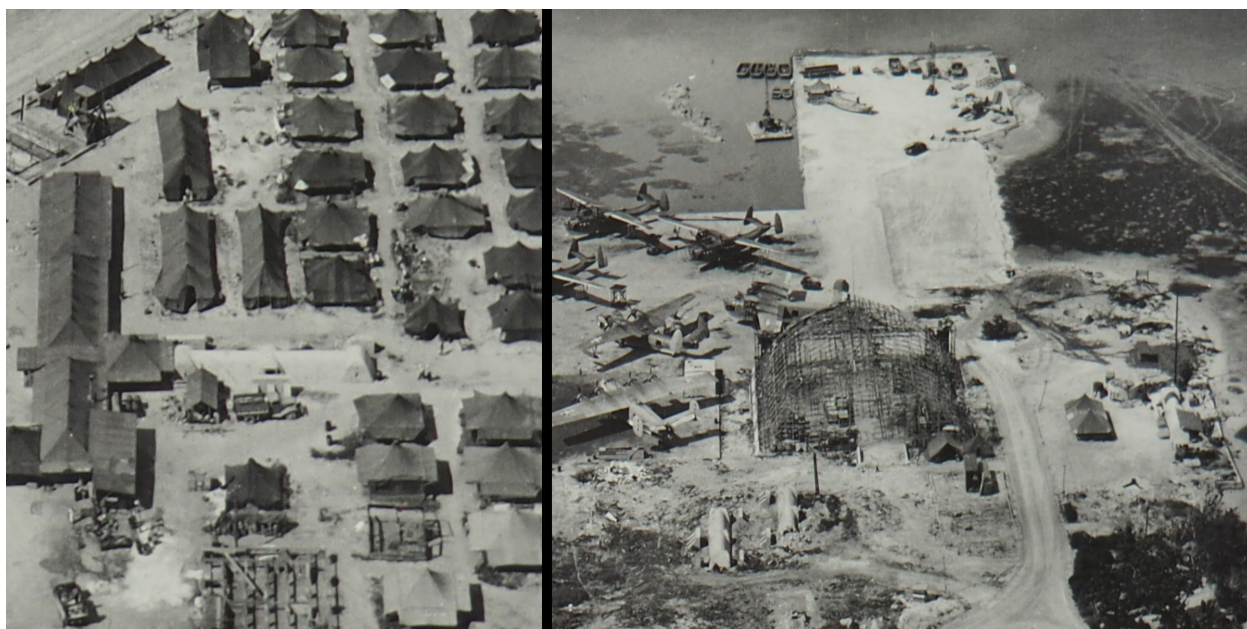
FIGURE 4.2. Enhanced aerial photo of Flores Point Seaplane Base. On the left, an air raid shelter being used for what is theorized to be part of the kitchen/mess hall. On the right, a concrete air raid shelter being used for radio broadcasting (note the radio tower directly adjacent to the structure). A recent enlargement of the seaplane ramp by U.S. forces is clearly visible in the photo as well (Photographs courtesy of CNMI HPO).

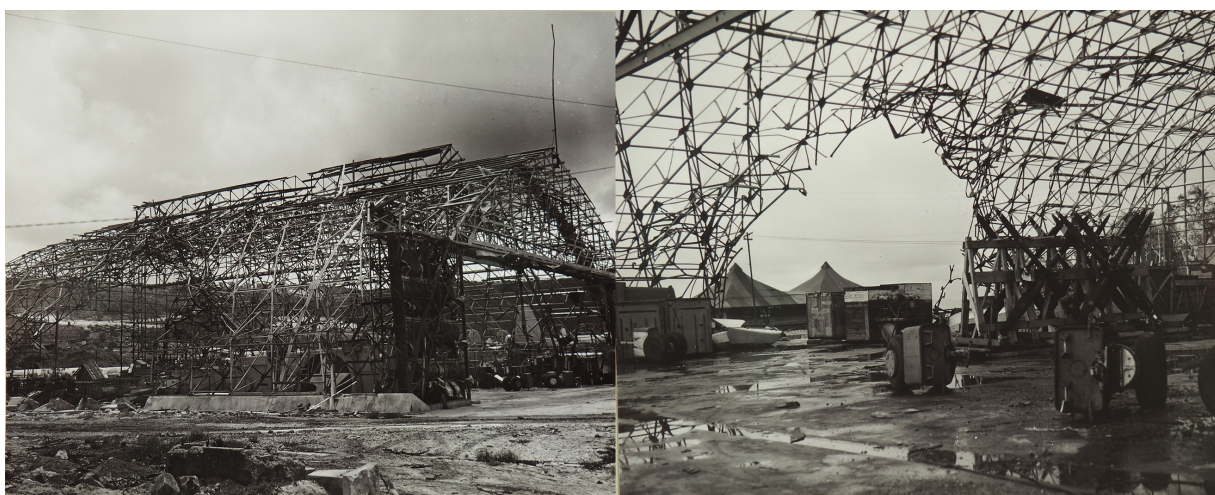
FIGURE 4.3. Photographs of former Japanese Hanger being repurposed for maintenance and storage by U.S. forces. Note the U.S. aircraft wing in the left photograph and the flying boat beaching gears and stored propellers in the right photograph (Photographs courtesy of CNMI HPO).

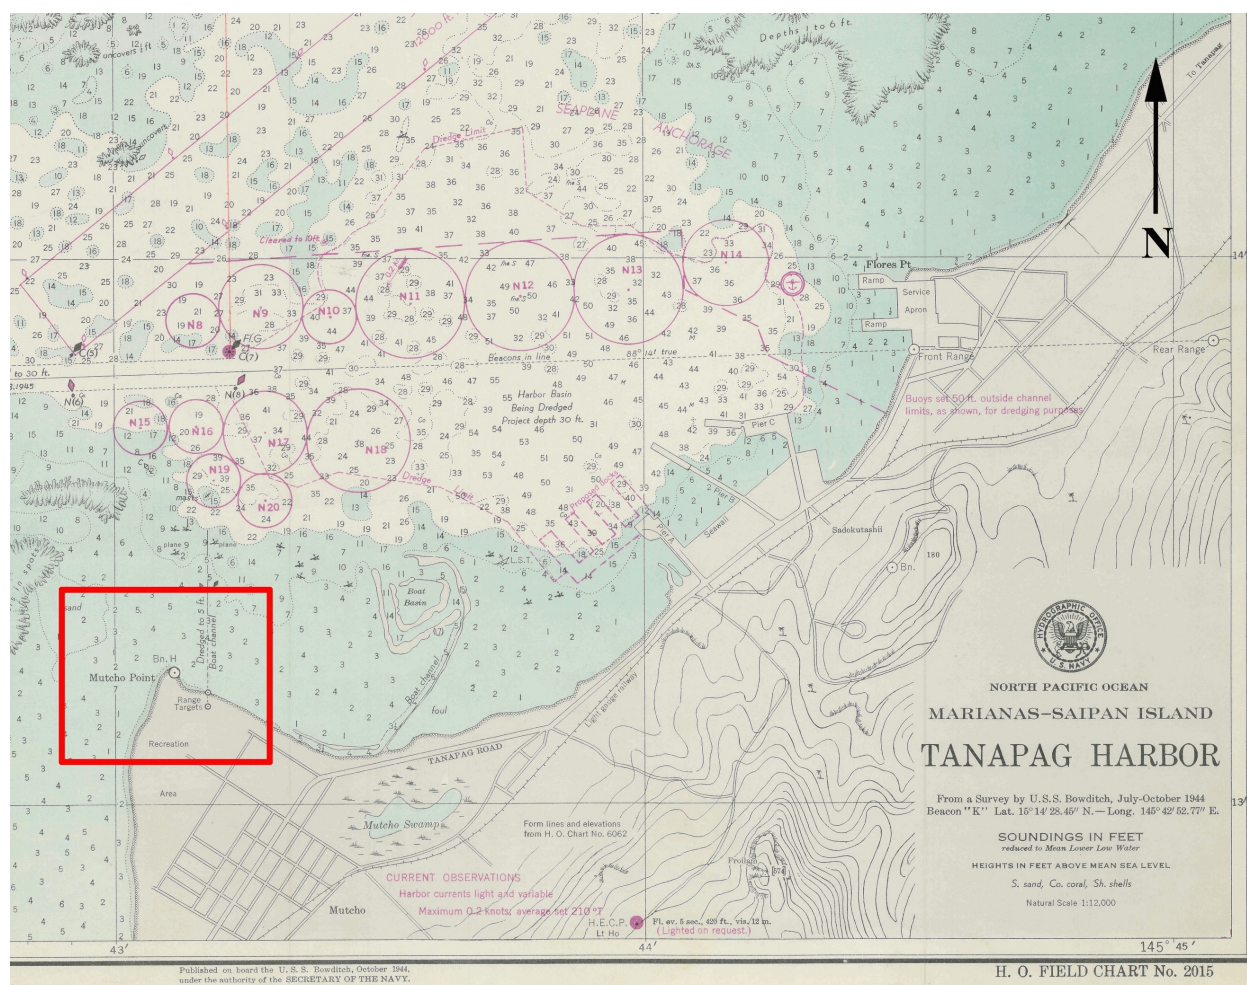
FIGURE 4.4. Red square emphasizing location of Beacon H. It is theorized by the author that this installation may have been destroyed by shoreline erosion (Image has been altered by author to emphasize area of focus. Chart courtesy of NARA, Record Group 37).

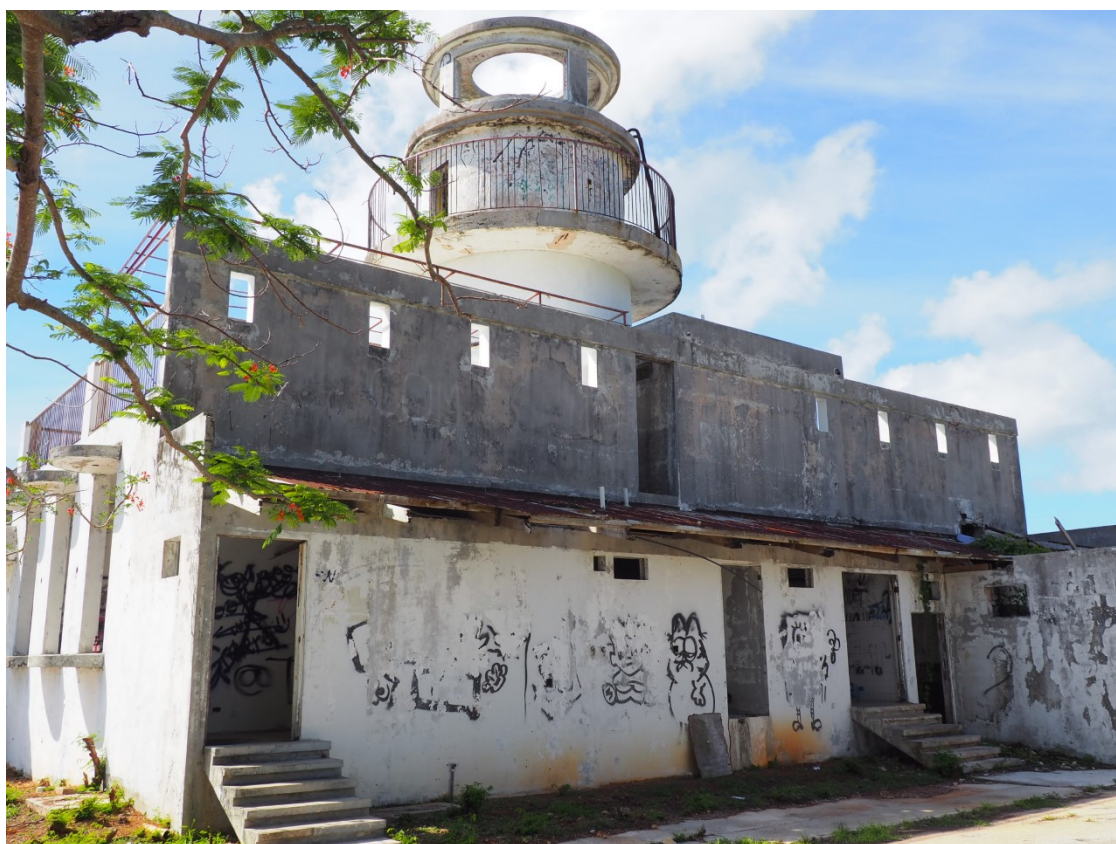
FIGURE 4.6. "Old Japanese Lighthouse". Photo taken looking approximately north (Photo taken by author on 9 July 2019).

Built on a prominent hill to the southeast of the small boat basin and directly to the south of the harbor docks, the lighthouse overlooks Tanapag Lagoon. As one of the few widely visible, permanent structures left standing after the battle it was often used as a control point for

triangulation by U.S. survey crews when constructing the harbor and seadrome (FIGURE 4.5; FIGURE 4.6). The structure appears to be abandoned and has fallen into disrepair. In numerous areas the concrete is beginning to disintegrate and the metal components, such as railings and stairs, are extremely corroded. Access to the interior was not attempted due to safety concerns.

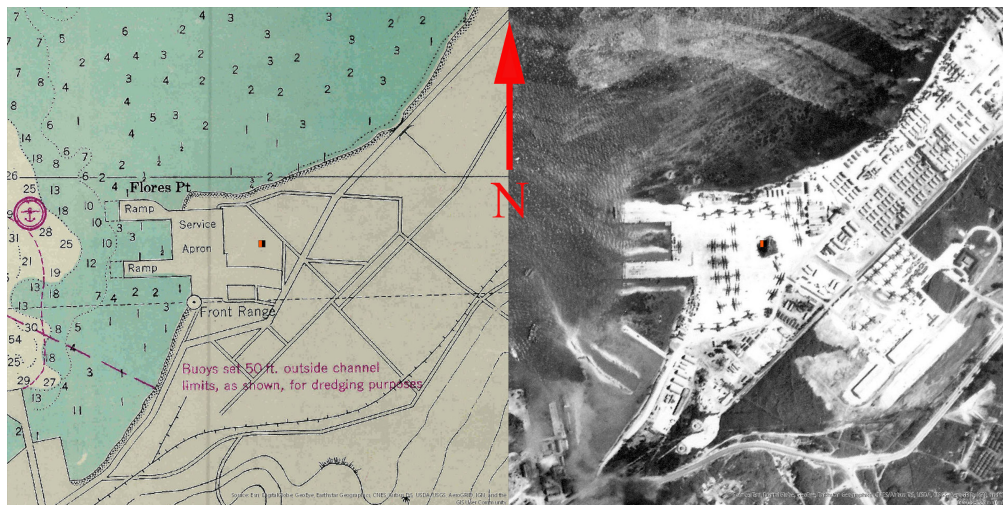
FIGURE 4.7. ArcGIS Overlay on H.O. Chart 2015 (left) and 1945 aerial photography (right) of Havana Tower atop former Japanese fuel bunker at Flores Point. Note the black and red GPS point in both images (Image and chart have been enhanced to emphasize control tower. Photograph courtesy of CNMI HPO. Chart courtesy of NARA Record Group 37).

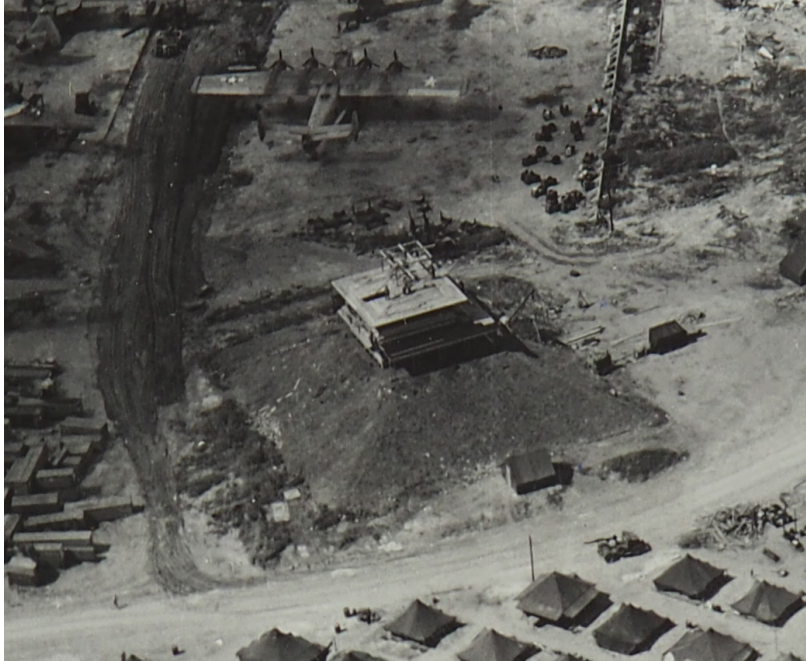
FIGURE 4.8. Aerial photograph of Havana Tower 10 November 1944. Original photograph enhanced by author to emphasize tower (Photograph has been enhanced to emphasize control tower. Photograph courtesy of CNMI HPO).

project (DeFant 2012). Among the features identified was the former Japanese fuel bunker turned U.S. seaplane base control tower, known as “Havana Tower” by U.S. forces (Base Facilities Summary: Advance Bases Central Pacific Area 1945. 160), located at UTM 55P 0364790E 1684209N (FIGURE 4.7; FIGURE 4.8; FIGURE 4.9). Although this site had been previously surveyed, it was decided to reexamine it with the specific focus of identifying evidence of its use by U.S. forces. The building is owned by the nearby Commonwealth Utilities Corporation and is used for storage. Access to the interior was granted, but due to the large amount of material inside no evidence of use by U.S. forces was observed. As the earthen revetments originally surrounding the exterior were removed sometime between the 1987 and 2011 surveys, access the roof to the building was not possible. Therefore, the presence or absence of cultural material related to the US control tower built there could not be confirmed (FIGURE 4.10).

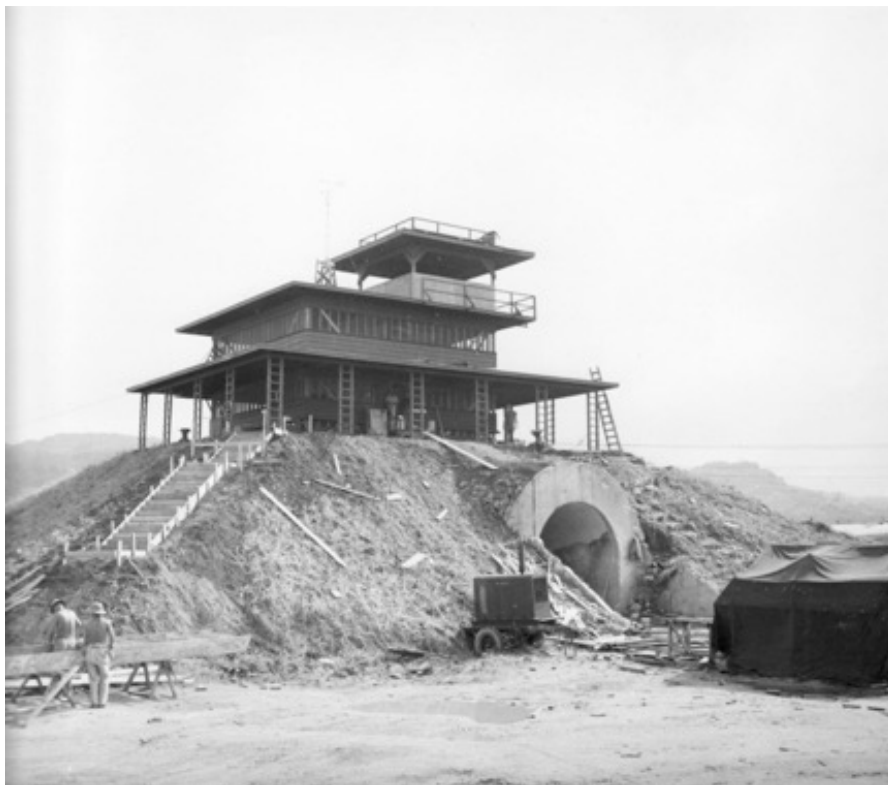
FIGURE 4.9. Havana Tower under construction on roof of former Japanese fuel storage bunker sometime in late 1944 (Image courtesy of DeFant 2012 page 16).

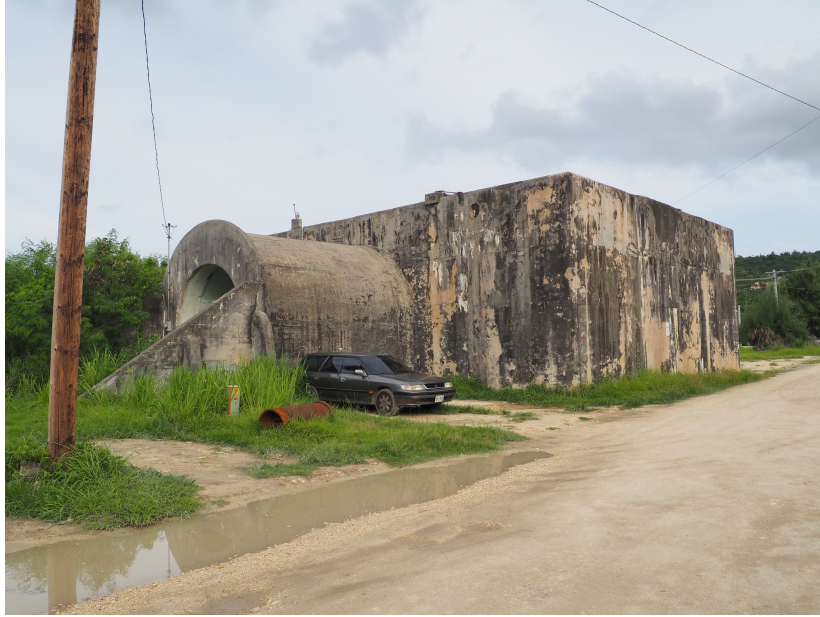
FIGURE 4.10. The former US control tower “Havana Tower” as of July 2019. Note the absence of earth ramparts and structure on the roof. Photo taken looking approximately west (Photograph taken by author on 28 July 2019).

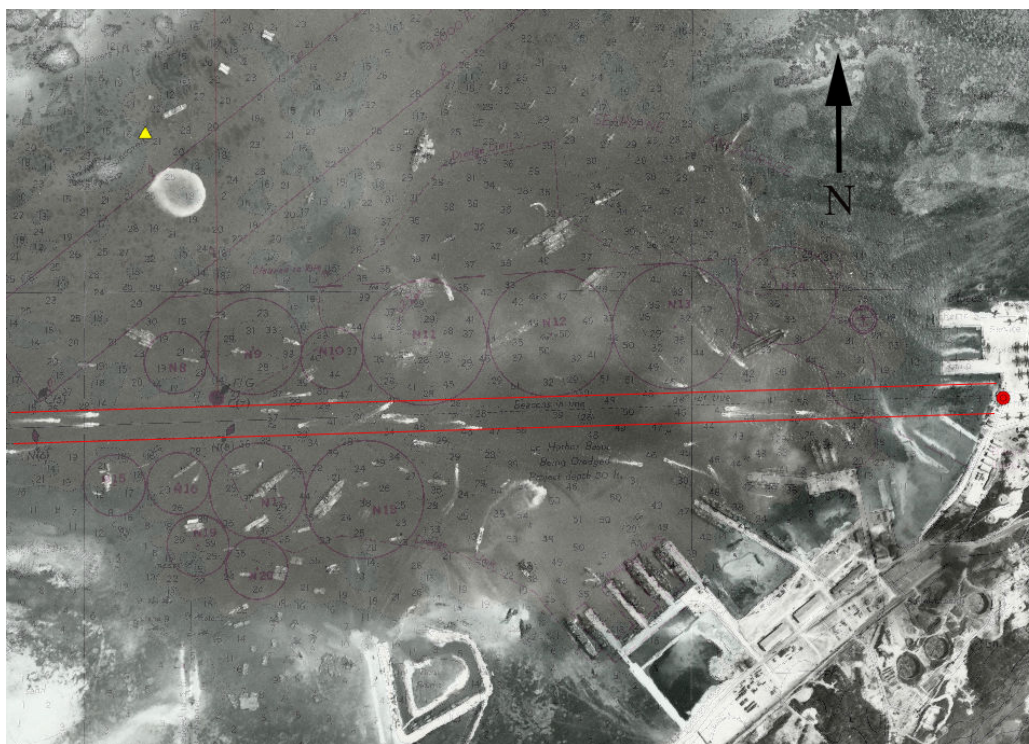
FIGURE 4.11. ArcGIS overlay of a 1945 aerial photograph of Tanapag Harbor and H.O. Chart 2015. The front range is in red and the red horizontal lines have been added by the author to emphasize travel area. Notice the boat traffic traveling in line with the range (Photograph courtesy of CNMI HPO. Chart courtesy of NARA, Record Group 37).

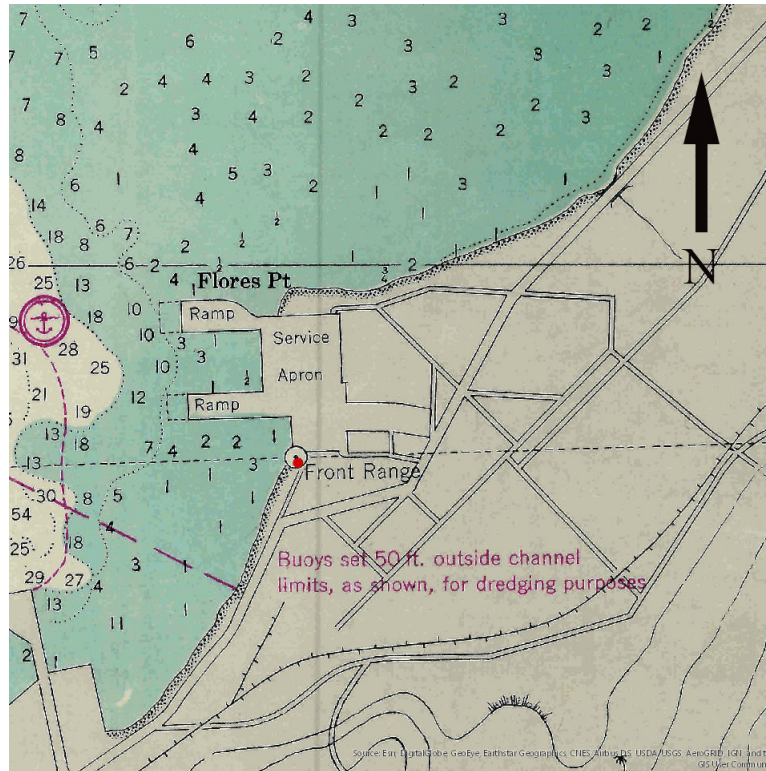
FIGURE 4.12. ArcGIS overlay illustrating GPS point of modern front range tower (red) superimposed on georectified H.O. Field Chart 2015 from 1944. Note the location of the modern range in correlation with the range in 1944 (Image enhanced to emphasize location of range. Chart courtesy of NARA Record Group 37).

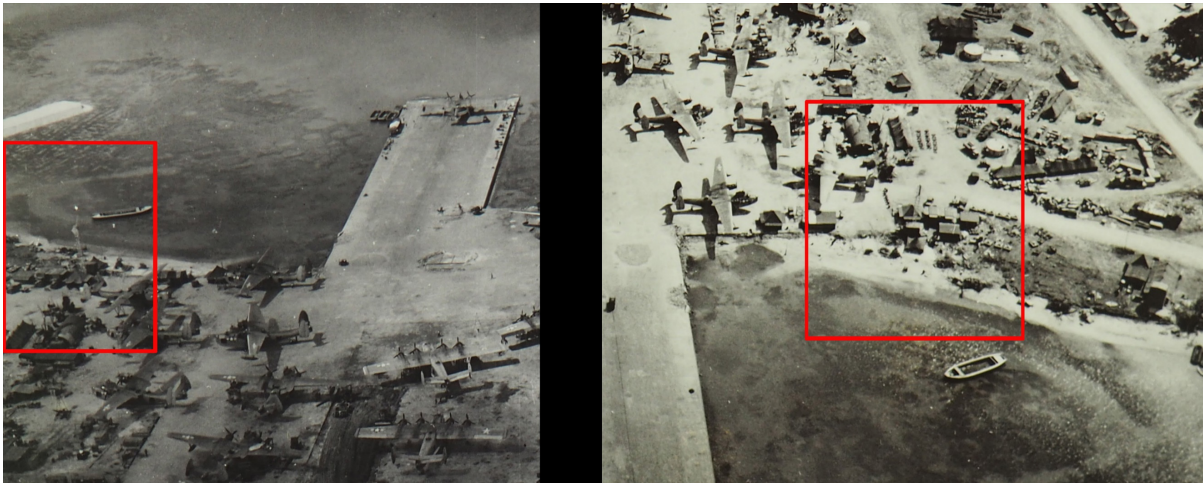
FIGURE 4.13. Aerial photographs of Flores Point Seaplane Base taken on 10 November 1944. Note the front range tower directly adjacent to the seaplane ramp in both photographs (Both images have been enhanced by author to emphasize range tower. Photographs courtesy of CNMI HPO).

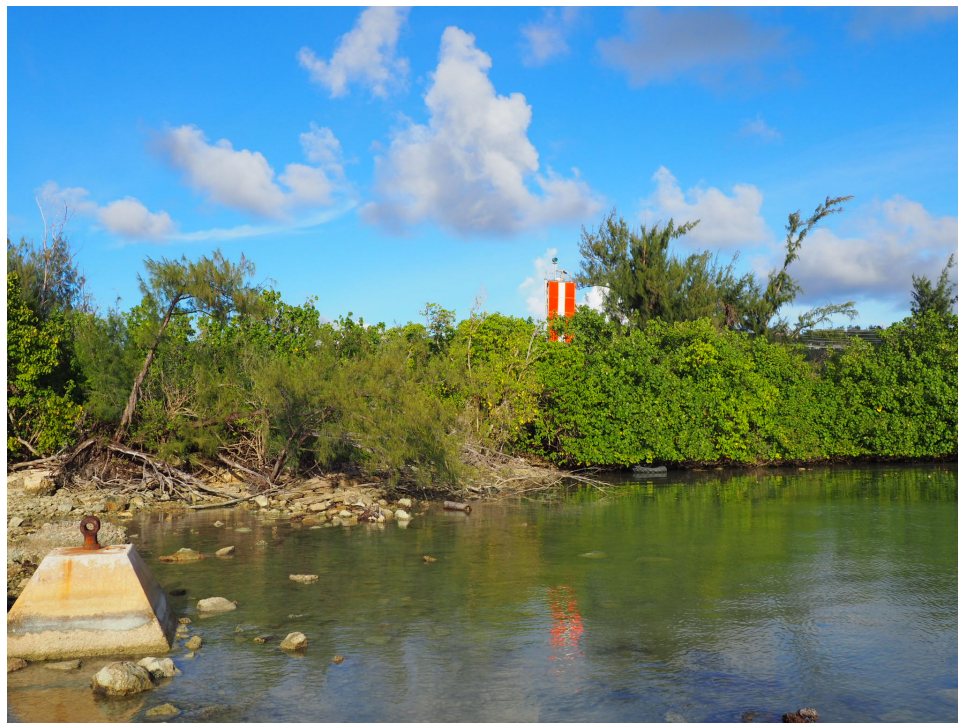
FIGURE 4.14. Modern front range tower at Flores Point (Photo taken looking approximately east by author 9 July 2019).

GPS coordinates of the approximate location of the front range located to the immediate south of the seaplane ramps at Flores Point were obtained through ArcGIS overlay and used to locate the remains of that site. It was determined that a modern range tower located approximately at UTM 55P 0364792E 1684075N was built directly on top of the original tower (FIGURE 4.12; FIGURE 4.13). The GPS coordinates of the modern tower are only approximate as the presence of thick vegetation and modern debris did not allow for closer access (FIGURE 4.14). The modern rear range was observed from a distance, but access to the facility could not be obtained (FIGURE 4.15). An ArcGIS overlay determined that this range was also in the approximate location of the wartime rear range.
